FHWA/IN/JTRP-2009/34

Final Report

**INNOVATIVE BRIDGE CONSTRUCTION
PROGRAM: IMPLEMENTATION OF FULL-DEPTH
BRIDGE DECK PANELS IN INDIANA**

March 2010

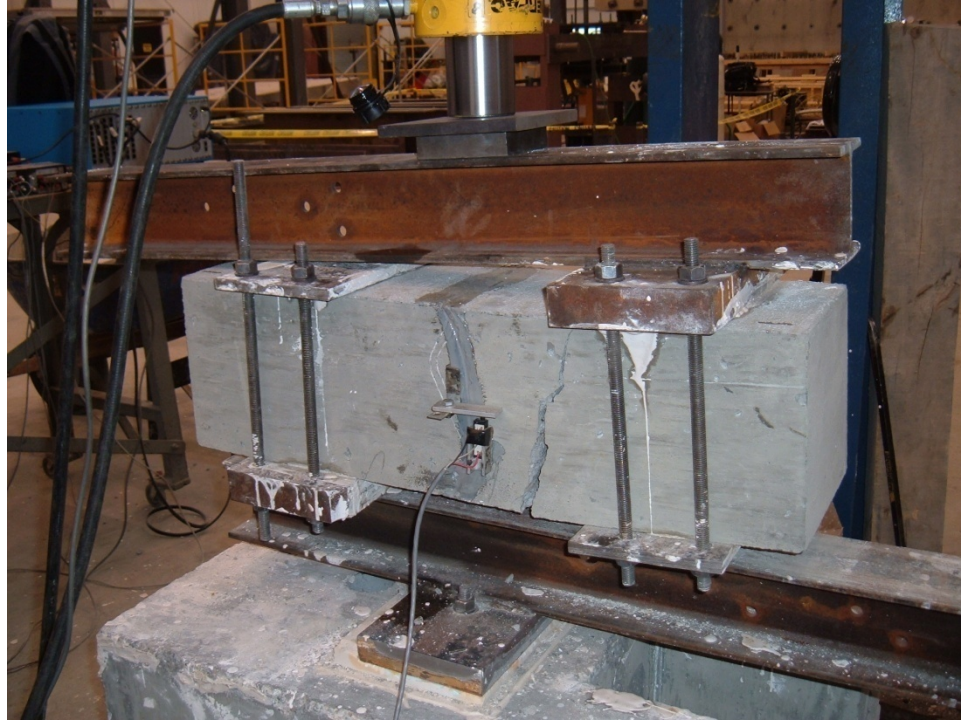
Figure 4.15: Failure of Specimen U-8-3

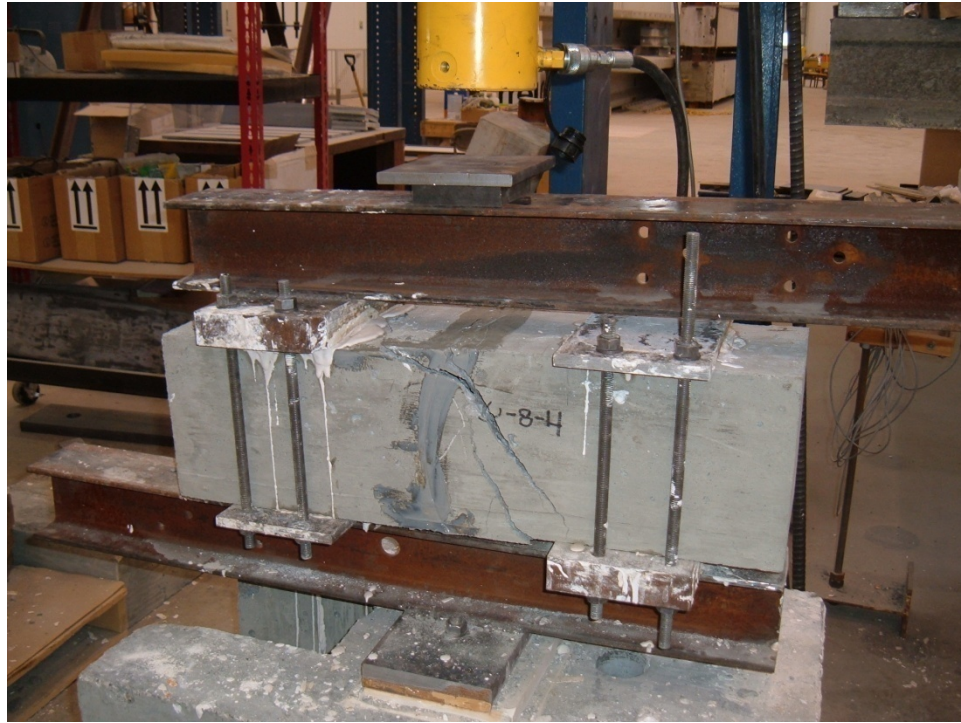
Figure 4.16: Failure of Specimen U-8-4

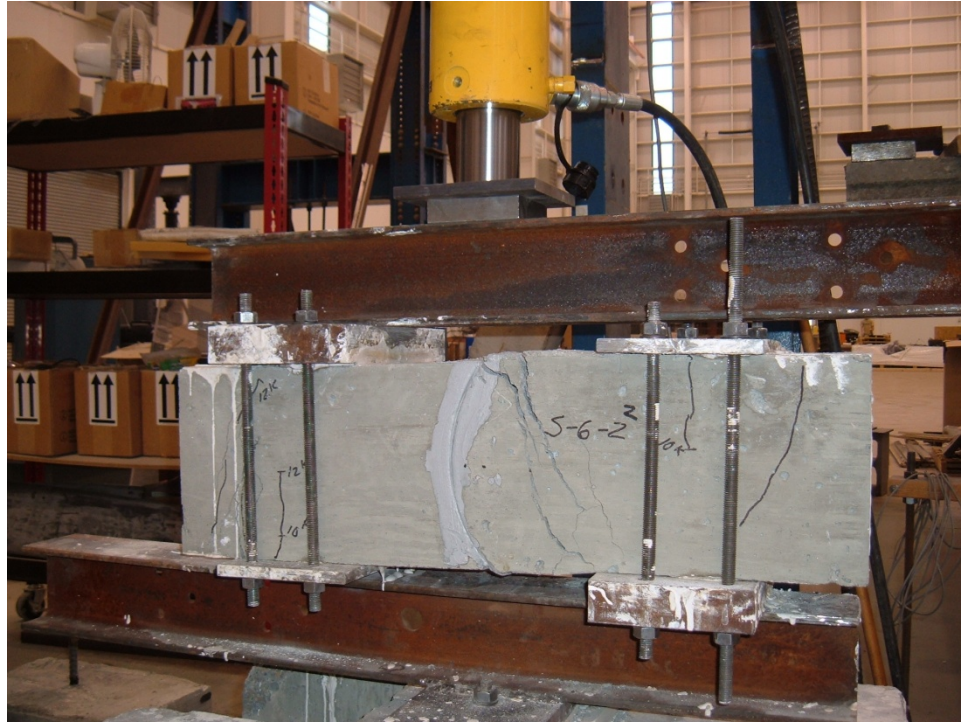
Figure 4.18: Failure of Specimen S-6-2

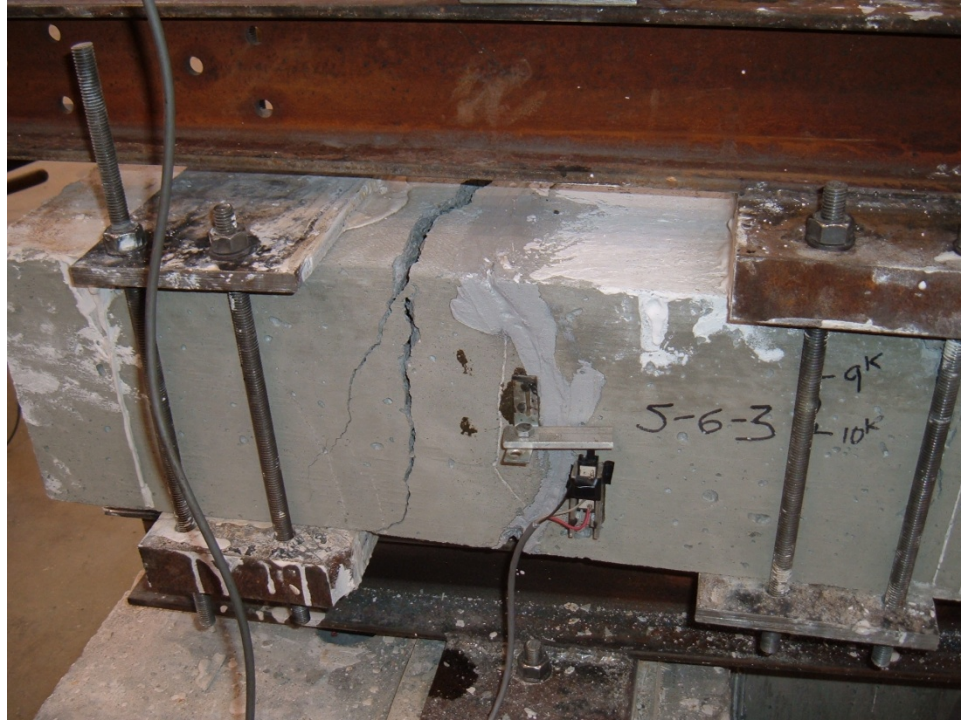
Figure 4.19: Failure of Specimen S-6-3

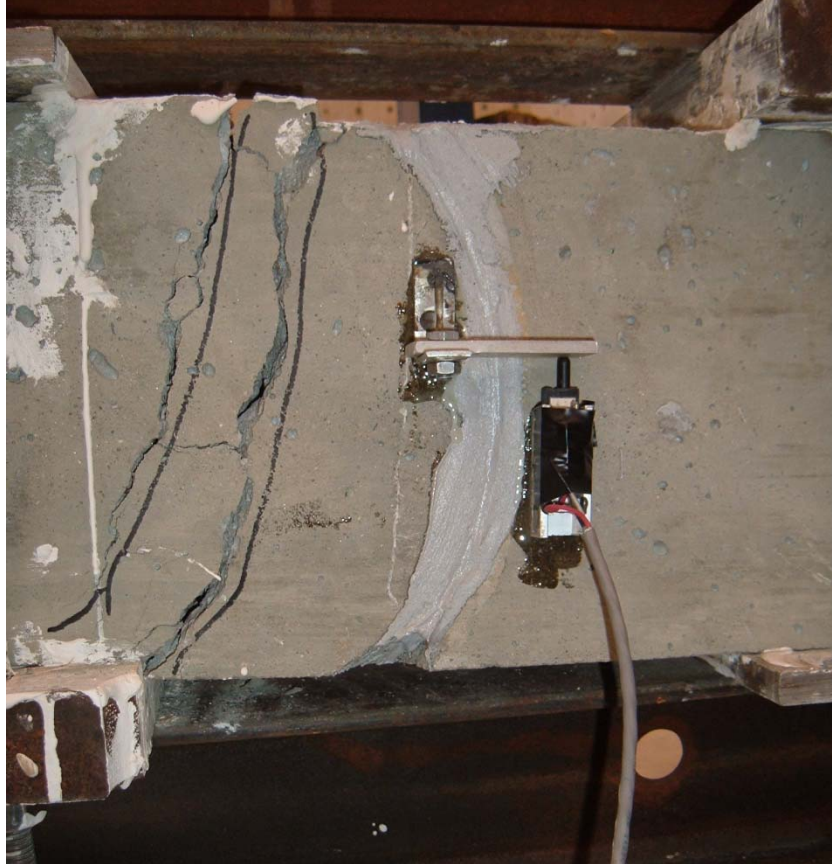
Figure 4.20: Failure of Specimen S-6-4

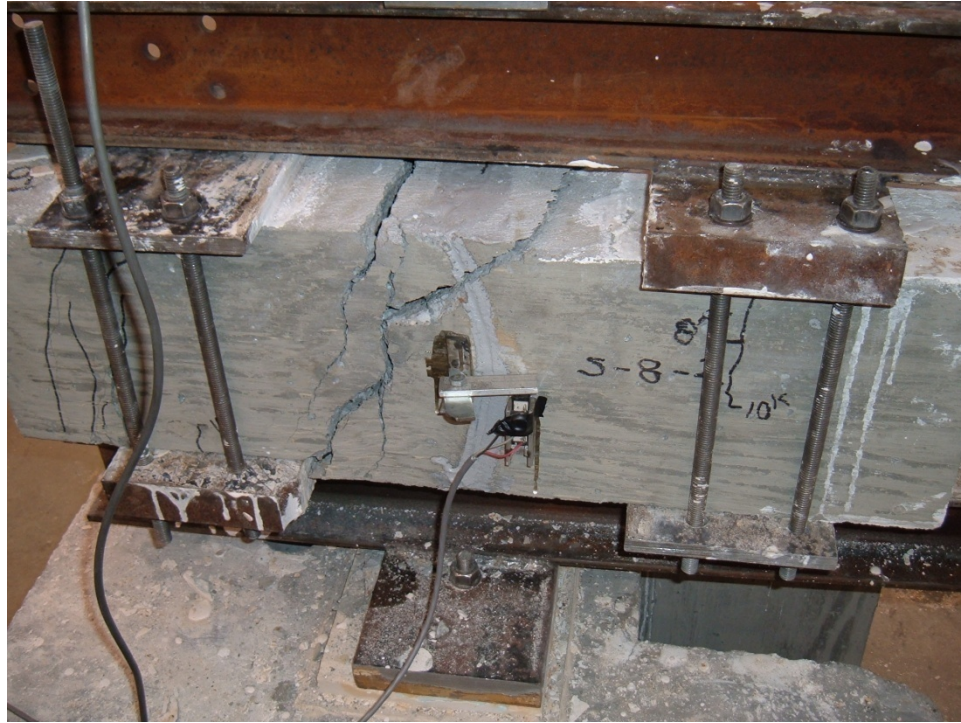
Figure 4.22: Failure of Specimen S-8-2

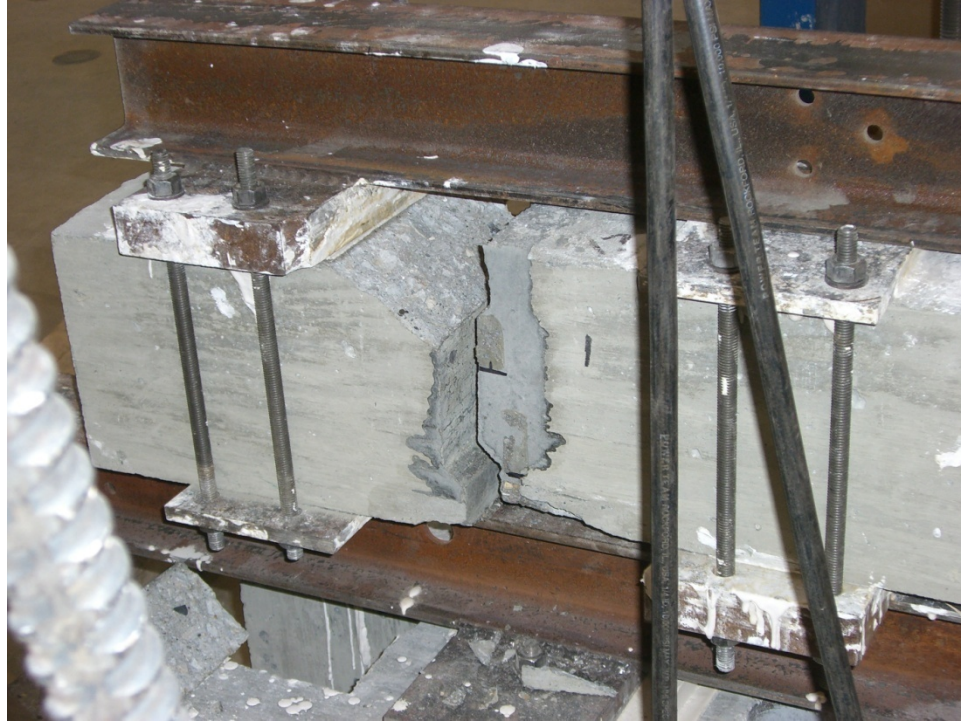
Figure 4.23: Failure of Specimen C-0-1

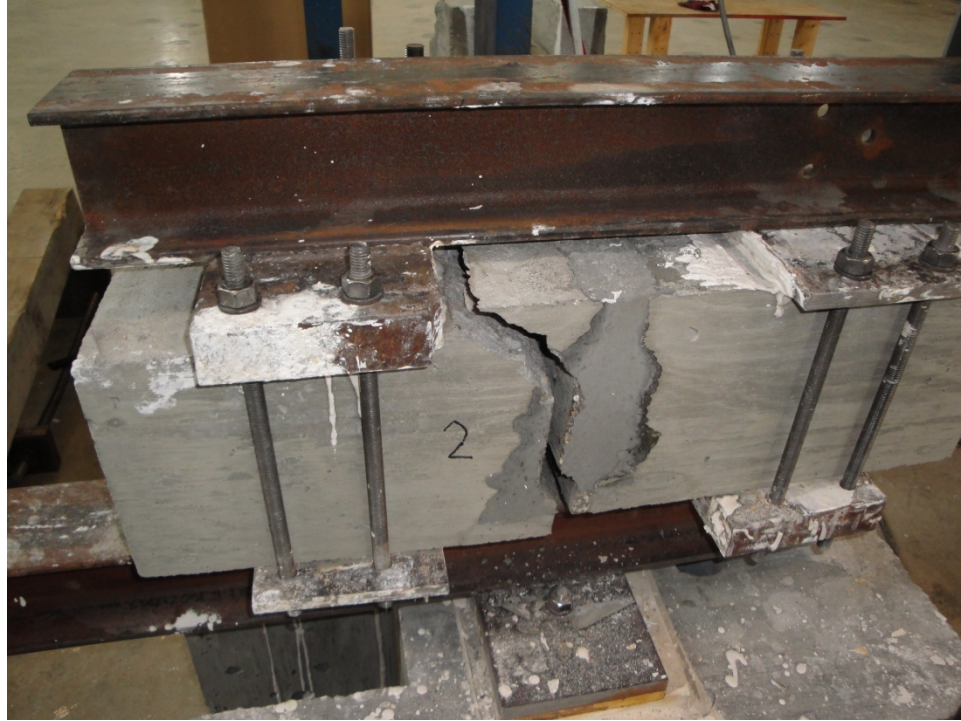
Figure 4.24: Failure of Specimen C-0-2

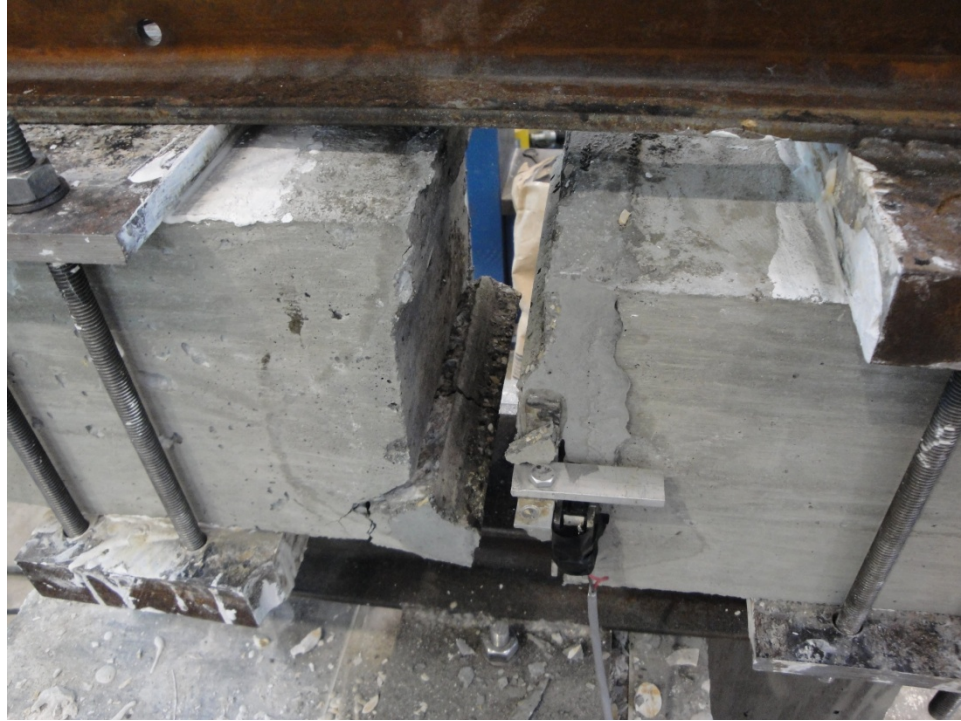
Figure 4.25: Failure of Specimen C-0-3

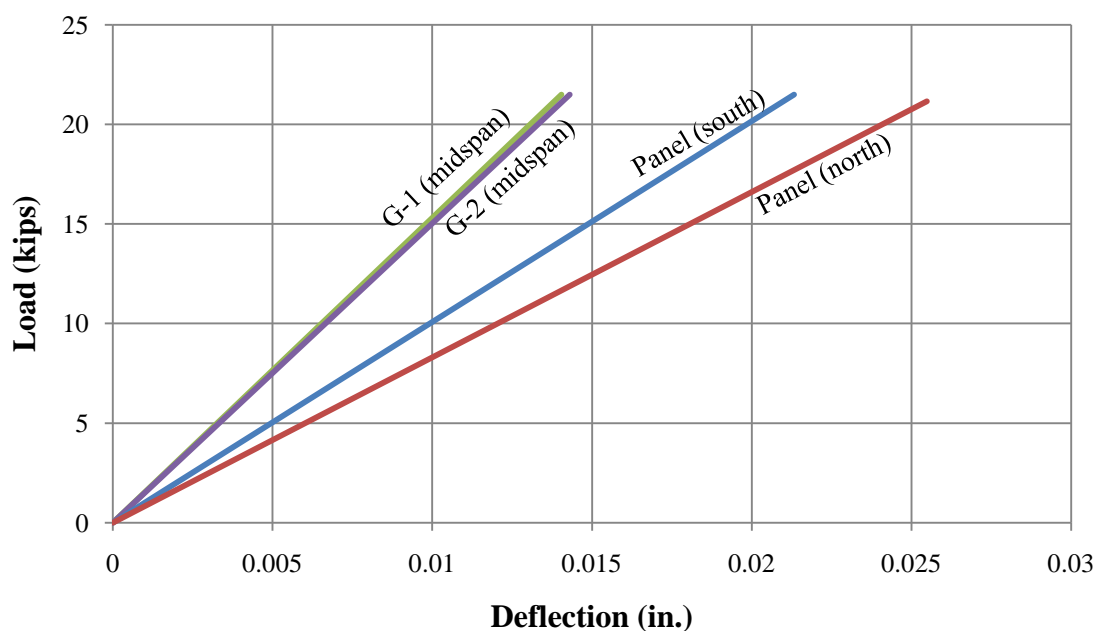
Figure 5.18: Static service wheel load-deflection response before cyclic loading

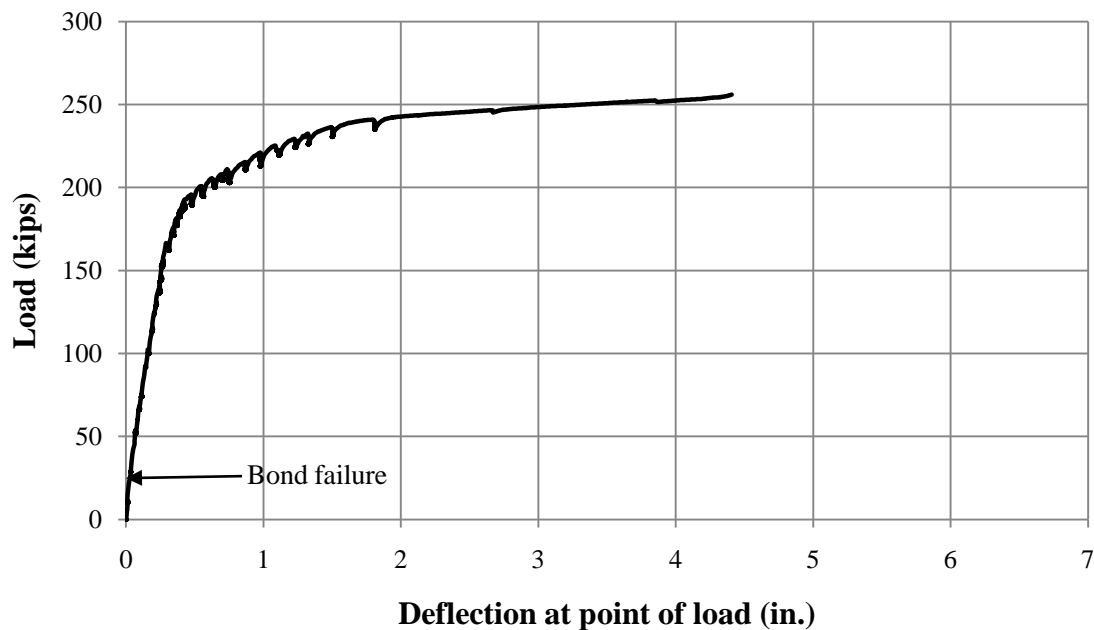
Figure 5.26: Load vs deflection - Specimen G-2

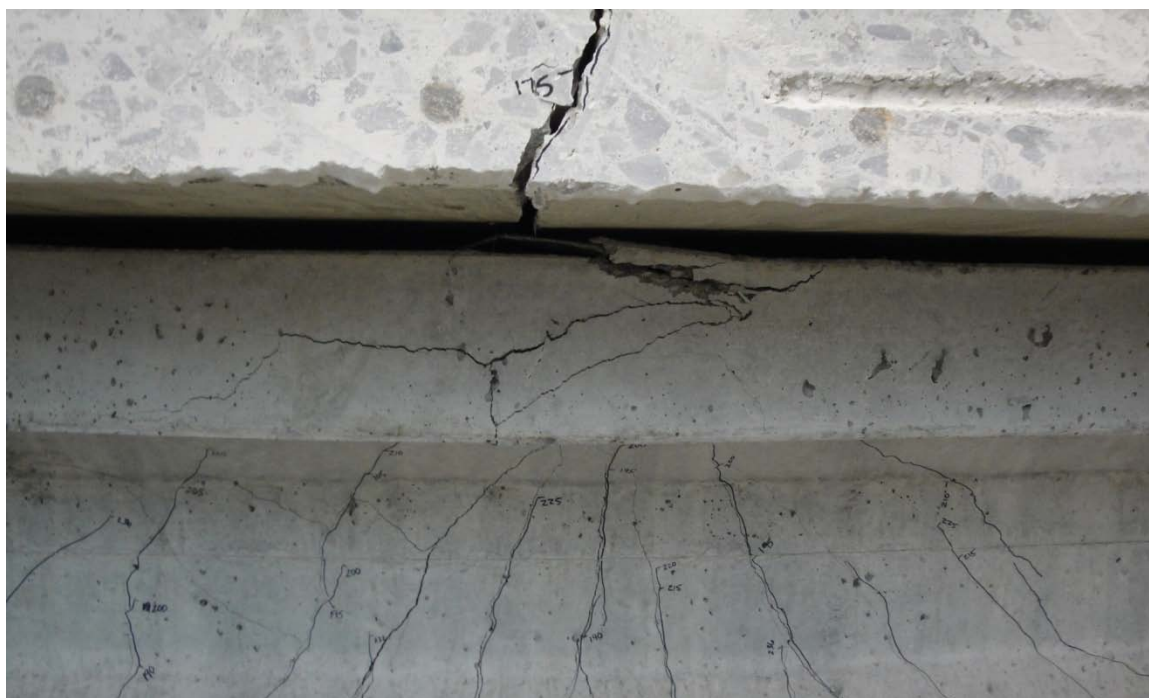
Figure 5.30: Failure of Specimen G-2

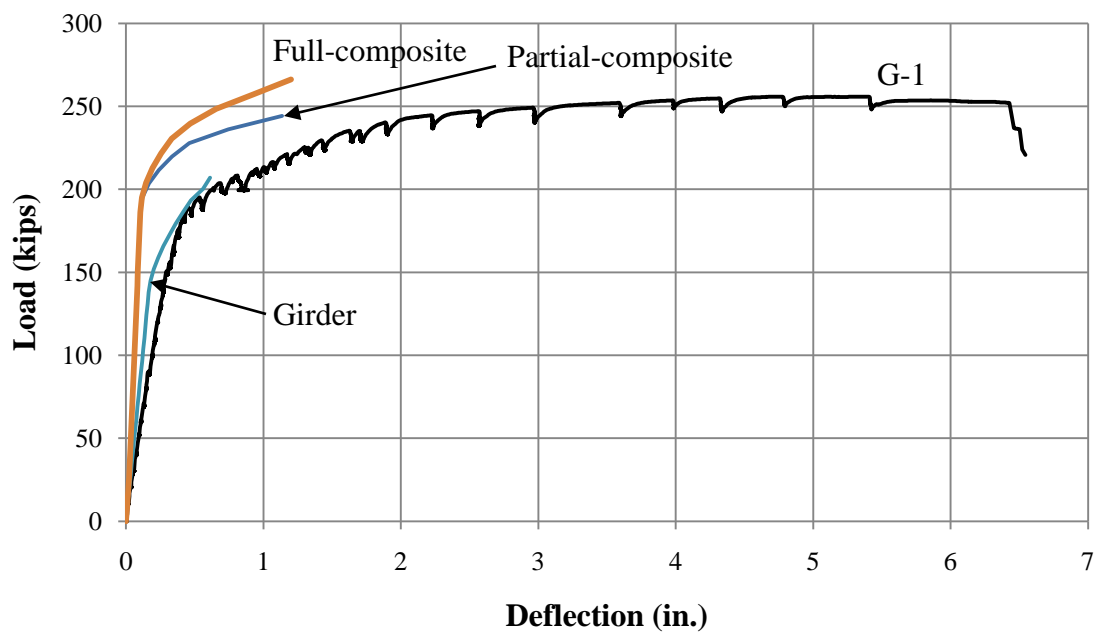
Figure 5.34: Specimen G-1 compared with calculated load-deflection paths

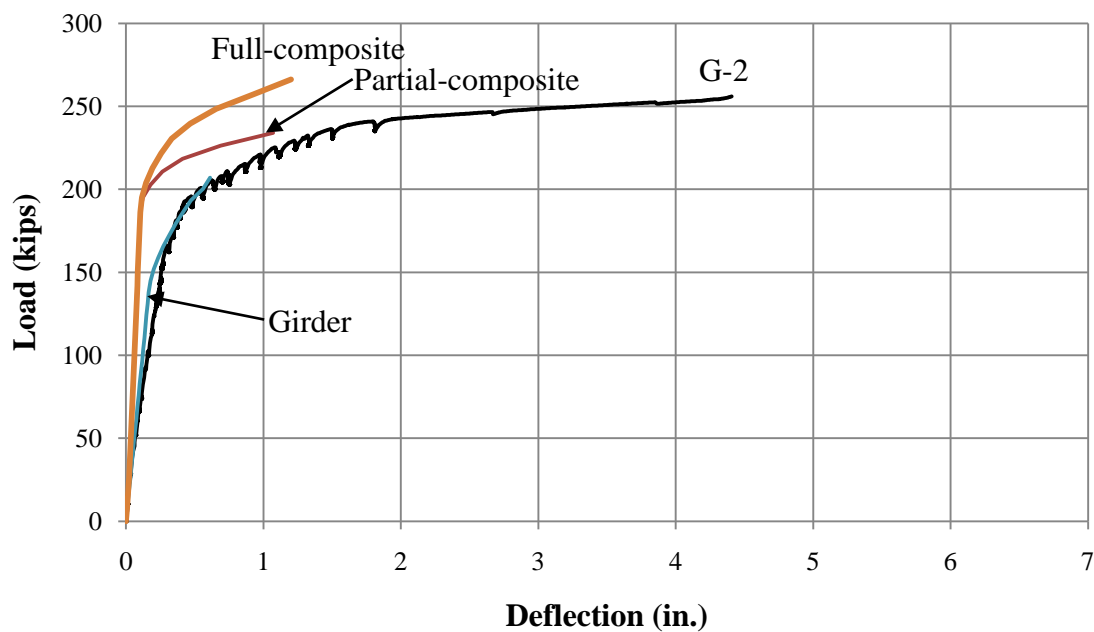
Figure 5.37: Specimen G-2 compared with calculated load-deflection paths
